Case Study - Overhaul Volvo Penta Marine Generator

Overhaul of Volvo Penta D13 Marine Genset

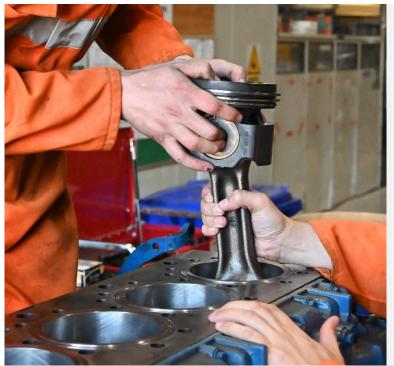
Engine disassembly and inspection

The engine overhaul process included the complete disassembly of the engine part-by-part into subcomponents to clean, qualify and test.

Each component was screened and checked against the manufacturer's specifications for the possibility of reuse to minimise cost for the customer.

Worn and damaged parts were segregated for customer inspection, if required.
