Case Study - Overhaul Volvo Penta Marine Generator

Overhaul of Volvo Penta D13 Marine Genset

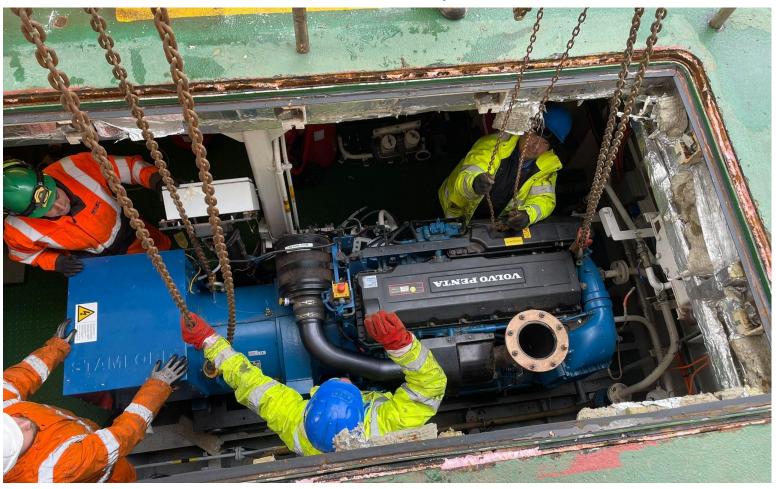
This Volvo Penta D13 B-E Marine Genset that powers a critical life-line RORO ferry was removed from the vessel by our Service Engineers for a scheduled 16,000-hour overhaul, carried out at our Glasgow Service Centre.

Thanks to continuous training in the latest Volvo Penta technology and repair methods, as well as the use of exclusively Genuine Volvo Penta Parts, the engine was completely overhauled in accordance with OEM specifications by our factory trained Workshop Technicians.

The generator was finally fully load tested, witnessed by the customer, then reinstalled back into the vessel.

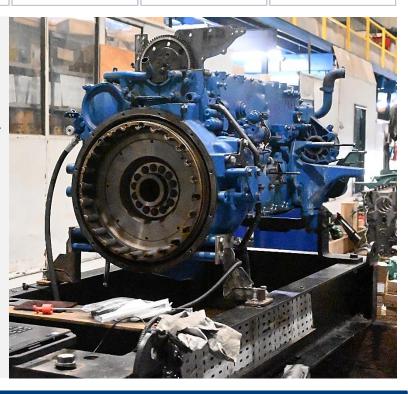
The engine overhaul process included the complete disassembly of the engine part-by-part into subcomponents to clean, qualify and test.

Each component was screened and checked against the manufacturer's specifications for the possibility of reuse to minimise cost for the customer.

Worn and damaged parts were segregated for customer inspection, if required.

The engine reassembly processes included using rebuilt parts and components and new wear parts (gaskets, seals, bolts, screws, etc.)

Our in-process inspection and tests carried out complied with Volvo Penta guidance and overhaul specifications.
