#### Case Study - Overhaul Offshore Cement Pump Transmission

#### Overhaul 4 x Allison 4700 OFS Transmissions

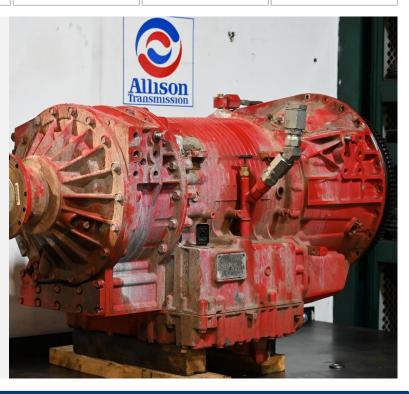
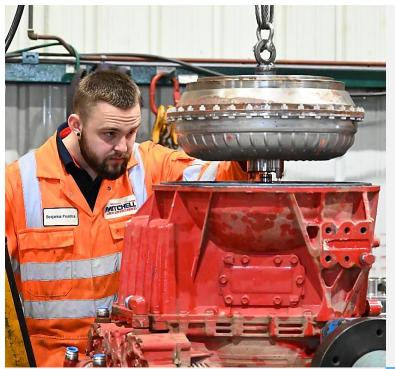
The transmissions were disassembled part-bypart to clean and qualify.

Each component was visually and physically checked against Allison's wear limits and tolerances for the possibility of reuse to minimise cost. All external components were cleaned and specially treated to remove painted surfaces and weathering from the extreme harsh corrosive sea air environment the transmissions are required to operate in.

All worn beyond reuse and damaged components were segregated for customer inspection and subsequent scrapping.

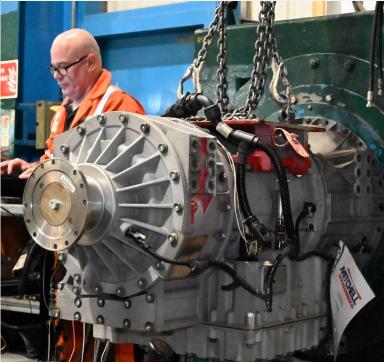
All components and subassemblies were rebuilt and checked to comply with Allison service manual instructions.

New components needed were all brand new, exclusively Allison Genuine Parts™. Quality inside means you get a more reliable, dependable remanufactured transmission.

Following completion of rebuild all 4 transmissions underwent a dynamometer test to ensure they were operating exactly in accordance the original factory specifications.

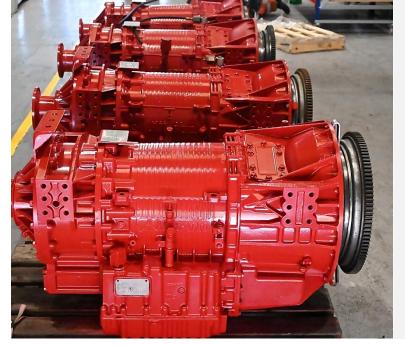
Upon successful completion of dynamometer testing each transmission was drained down and prepared for painting and shipping in accordance with the customers specified requirements.

Final inspection and sign off is completed with the transmissions now ready for delivery back to the customer in a 'just-like-new condition'.
